# Investigation Report

October 27, 2010

Aerial Lift Accident

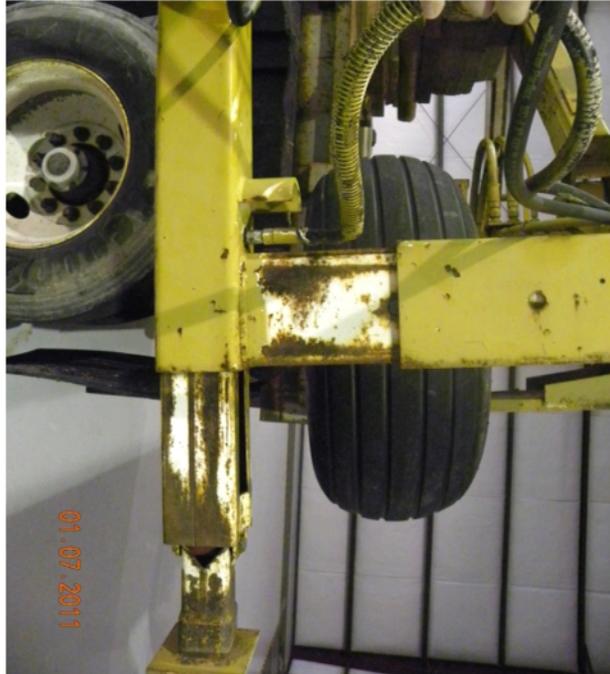
Second, four pins normally attached to the outrigger beams were missing and the outrigger sockets were corroded such that the beams were “frozen” 1-5 inches beyond the normal position.

Similar to the fractured railing platform pins, the corroded condition of the outrigger beams indicated that the pins had been missing for a significant period of time and should have prevented the lift from passing inspection, most recently in 2009. However, “because the beams were extended beyond the normal pinned position[,] the stability footprint of The Lift was increased and thus its resistance to tip-over was increased due to the somewhat larger base.” Therefore, the unpinned outrigger assemblies in no way caused or contributed to the accident.

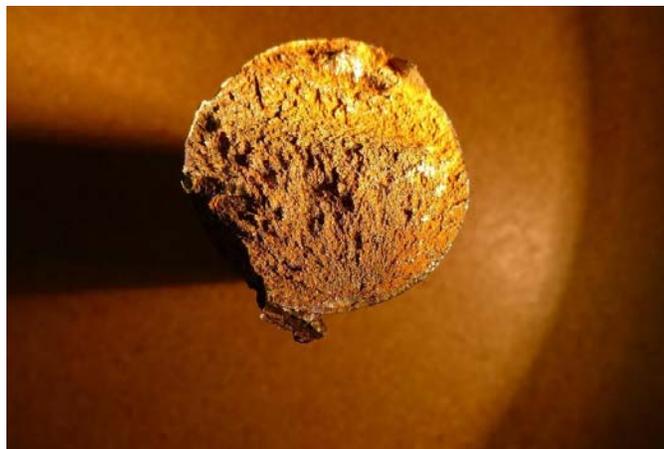
Finally, Recard’s post-accident analysis revealed that the center pivot shaft was fractured. Because a fractured pivot shaft can decrease lift stability, Recard deemed it necessary to determine whether the fracture preexisted the accident or occurred as a result of the accident. Unable to determine when the fracture occurred through visual inspection, Recard recommended metallurgical evaluation to verify the age and extent of the cracking. Accordingly, the University asked SEA metallurgist Dr. Nicholas Biery to examine the shaft’s surface. *See* Exhibit 10 (Biery’s expert analysis).

Based on his examination of the fracture surface, Biery concluded that “[t]he pin most likely broke due to impact of the platform and scissor assembly with the ground.” Because the fracture did not preexist the accident, it was also excluded as a cause.

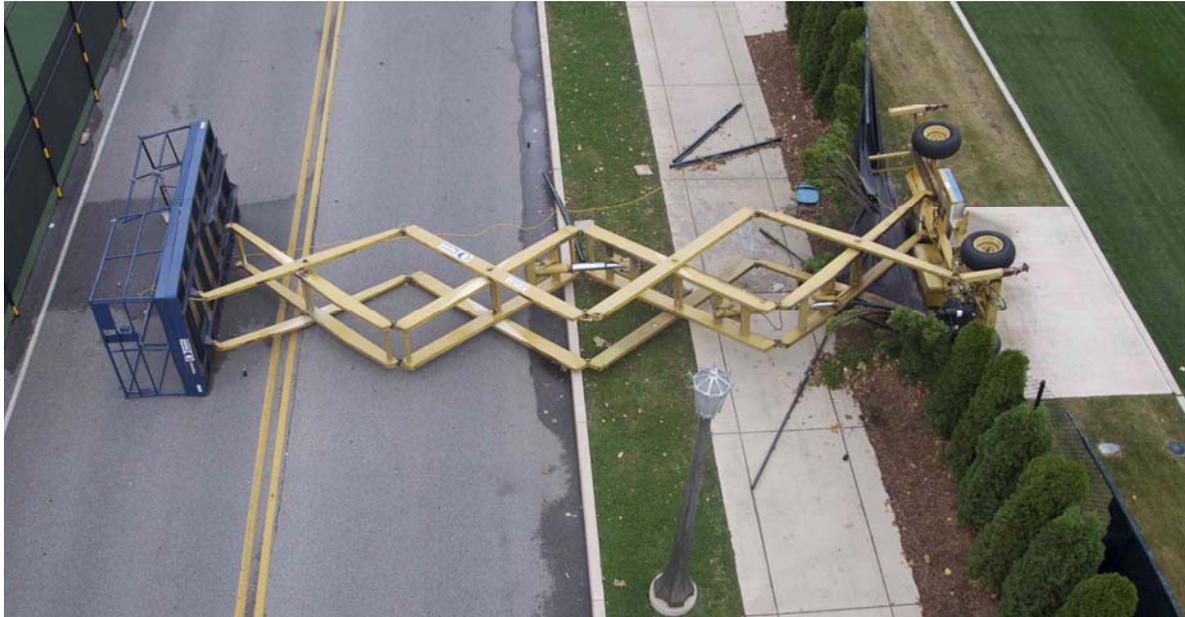
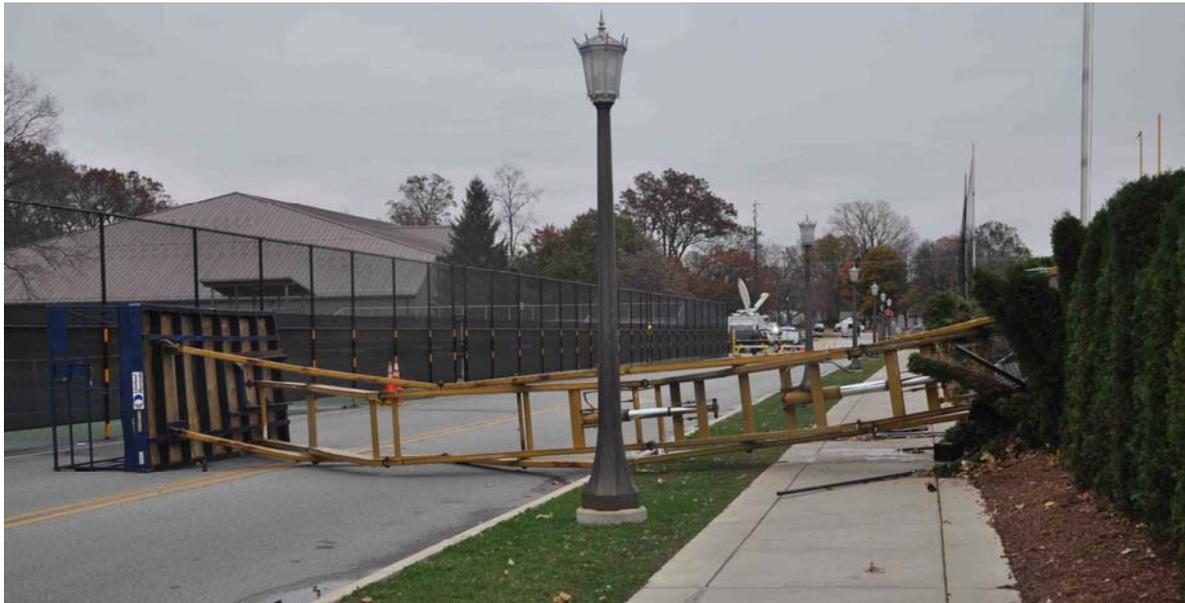
Figures 1a and 1b. Marklift scissor lift at accident site.

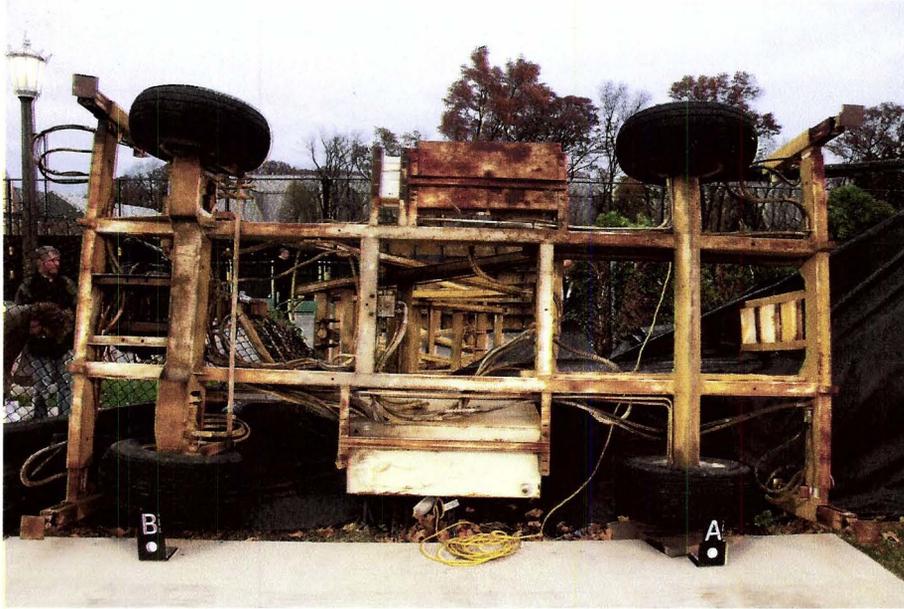
Photo 1 - Lift in Tipped Condition Showing Outrigger Position

The outrigger beam weldment (Figure 2) is designed with two holes in the beam into which the pin may be inserted, one hole close to the vertical jack and one hole at the aft end of the beam. The Marklift operator's manual is silent as to which hole should be used during "on outrigger" operation. However, based on a review of the parts manual drawings (which shows the lift in an elevated position with the outriggers pinned in the hole closest to the vertical jack), an evaluation of the loading and structural properties of the outrigger beam, and my experience with other scissor lifts of this type; it is my opinion that the pin hole closest to the vertical jack is to be used for pinning the outrigger beam during operation.

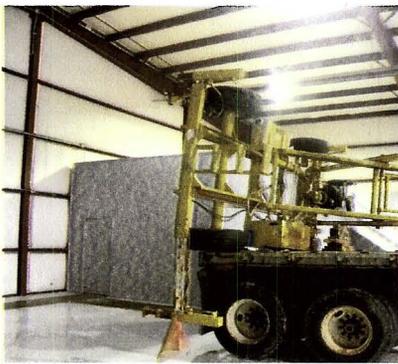
Photo 2 - Right / Left Rear Outriggers

Post-accident inspection of The Lift revealed that the four (4) pins which are normally attached to the outrigger beams by means of a chain lanyard and are designed to secure the beams into position were missing. Further inspection revealed that the outrigger beam sockets were corroded to the extent that the beams were “frozen” into position in the horizontal direction to a point where they were extended 1-5 inches beyond the normal pinned position. It should be noted that either as a result of the tipover accident or post-accident transportation of The Lift the corrosion “lock” on the right rear outrigger beam was broken and the outrigger beam became completely extended and free from the frame (Photo 2).

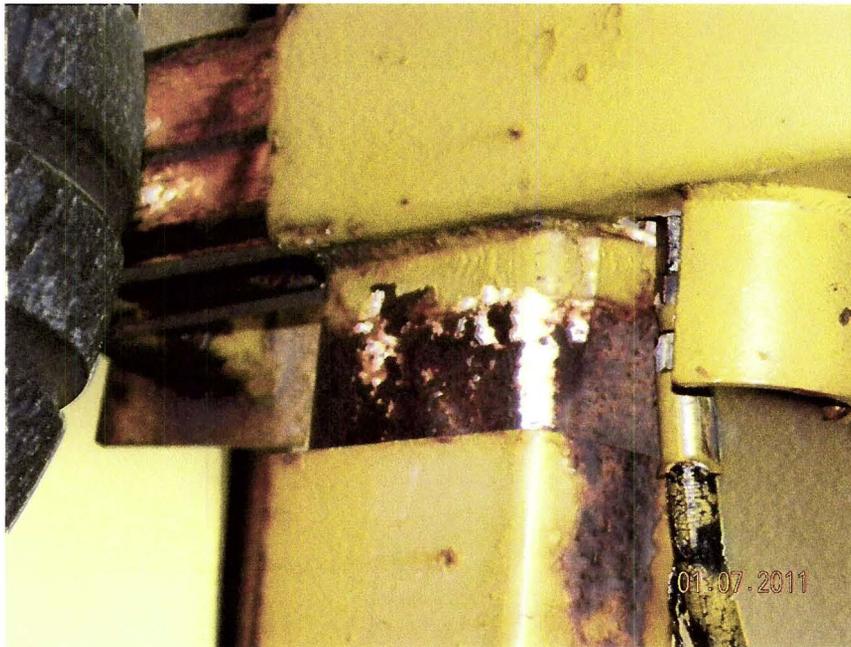
Photo 5 - Outrigger Beam Showing Extension – Painted and Unpainted (Corroded)

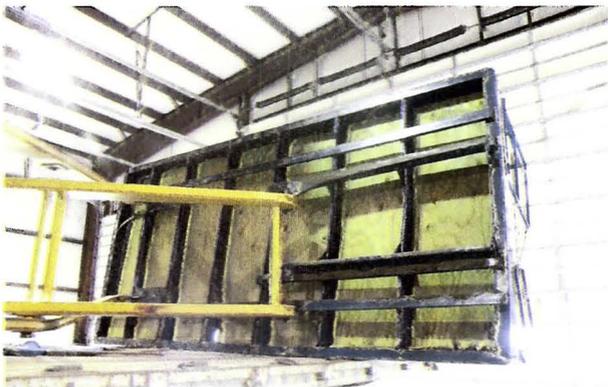
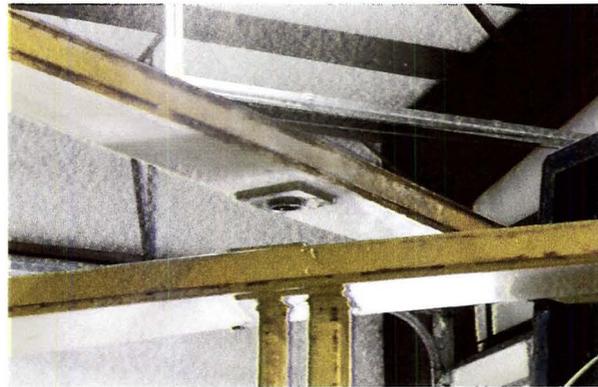
Post-accident inspection of The Lift determined that the center pivot shaft of the top inner scissor arm assembly, on the left side of the lift had completely fractured, thus separating the inner and outer scissor arms (Photos 6 & 7).

Photo 6 & 7 - Damage to Scissor Arms and Pivot Shaft

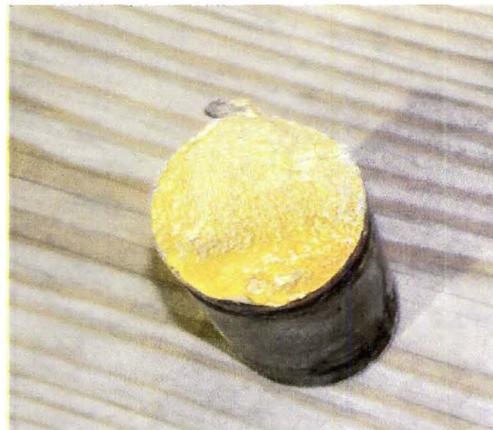
Photo 8 – Pivot Shaft Fracture Surface

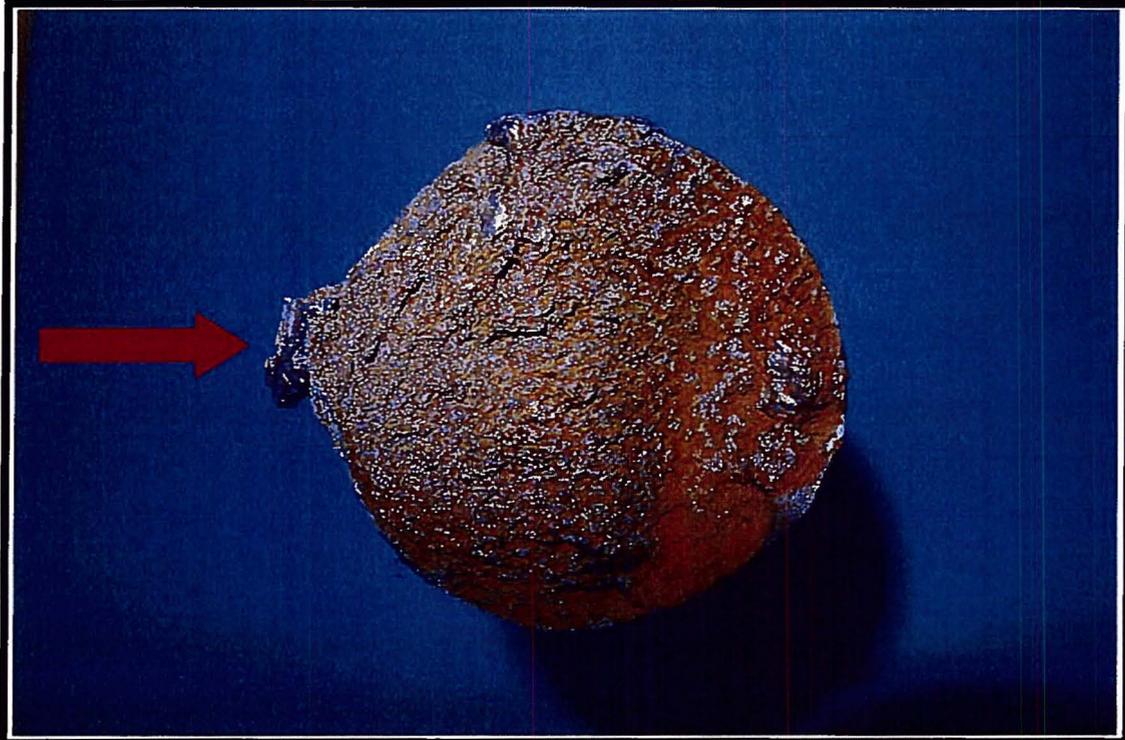
Examination of the fracture surface of the pin reveals that the fracture was brittle and, at least in the portions of the fracture surface not obscured by rust, propagated intergranularly (between rather than through the grains which make up the steel pin). The fracture origin is located on one side of the pin near the weld metal deposit. There is no indication of cracking prior to the final failure of the pin. Had the pin been cracked previously due to fatigue, the portion of the fracture due to fatigue would be much flatter and more uniform, and likely would have exhibited darker pre-existing rust.

**FIGURE 3:** End view of fracture showing weld metal (arrow).

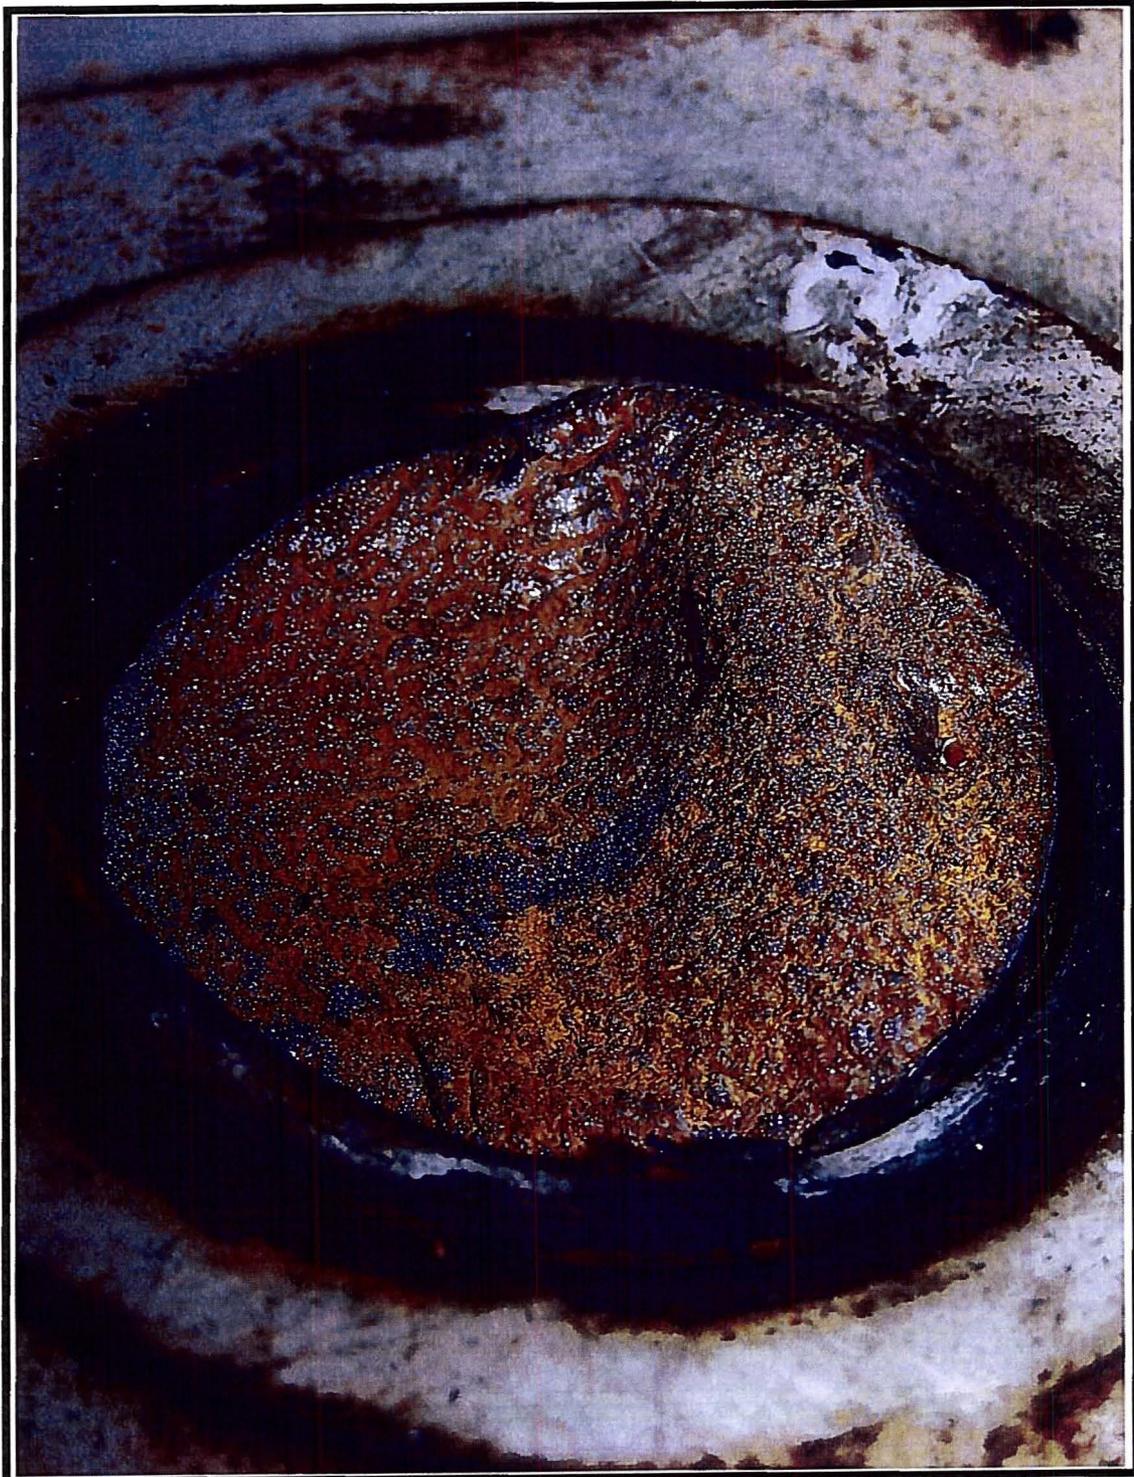
**FIGURE 4:** Picture of pin half still in place on scissor lift.

The lack of pre-existing cracking indicates that the fracture occurred as a result of a single-overload event. Furthermore, the brittle nature of the fracture indicates that the cause of the failure was likely an impact load. Pictures of the lift after it fell over indicate that portions of the "scissor" assembly of the scissor lift are bent (**Figure 5**). Falling over with the lift extended would produce large impact stresses in the scissor assembly, consistent with a bent scissor assembly and a broken pin. The pin most likely broke due to impact of the platform and scissor assembly with the ground.

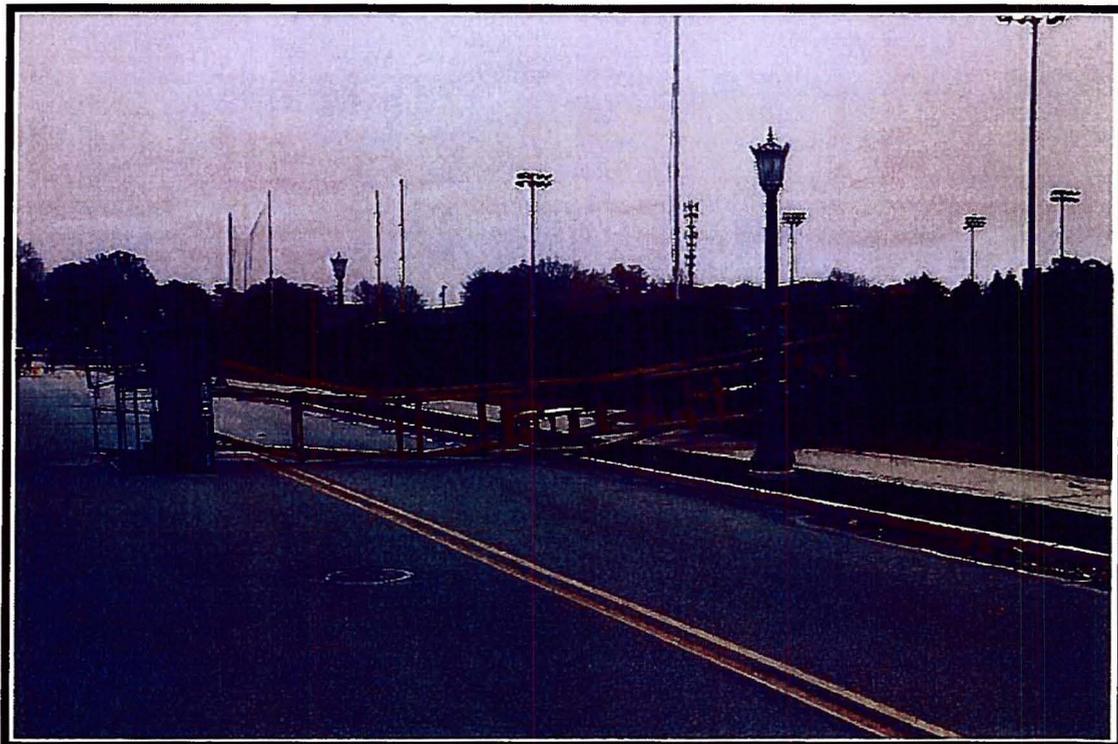
**FIGURE 5:** Photograph of lift after incident.
