# Investigation Report

October 27, 2010

Aerial Lift Accident

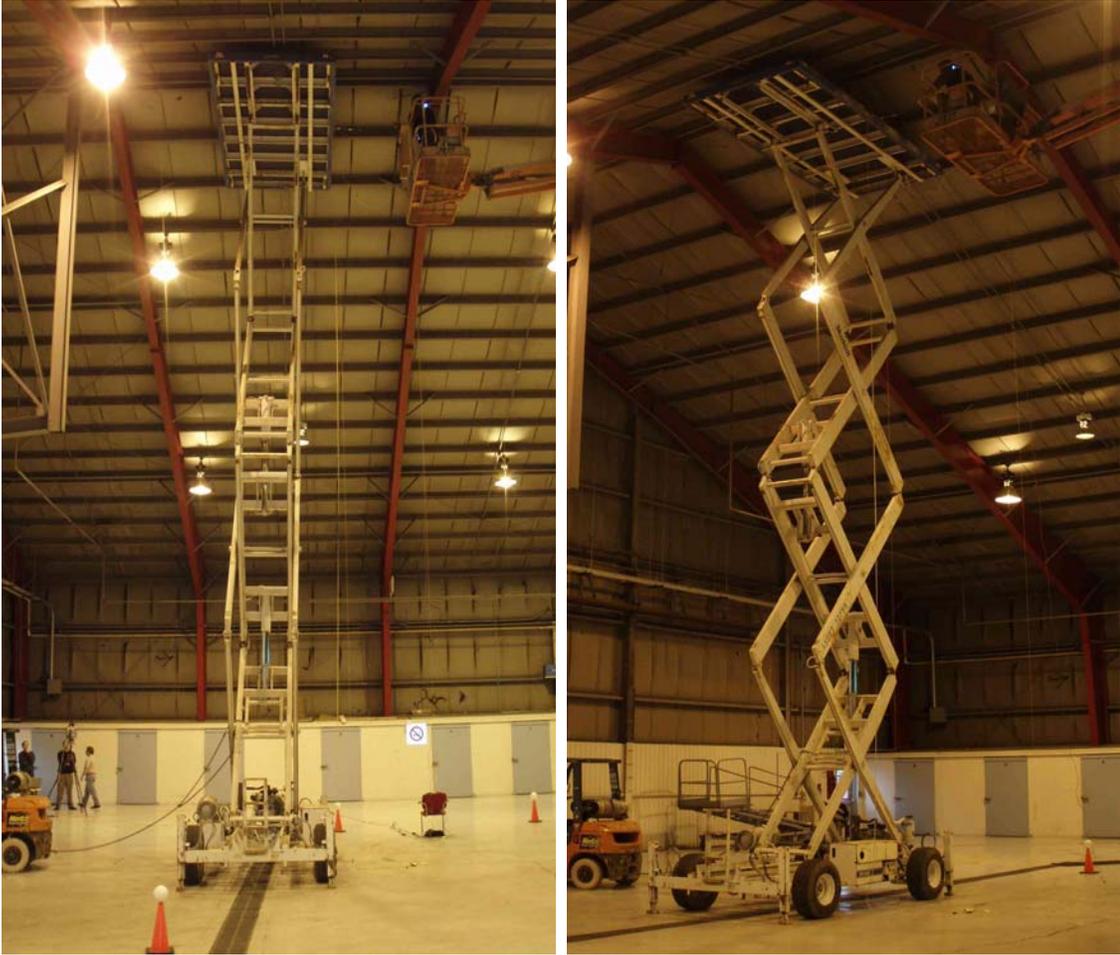
**Marklift under 200 lbf load at zero degrees**

Through state-of-the-art wind-loading analysis, Peterka used the generated models and deflection data to determine the three lifts' tipping-point speeds when raised to heights of 40, 35, 30, and 25 feet. He concluded that 49-53 mph winds would cause the Marklift to tip over when fully extended to 40 feet. The SkyJack and JLG lifts, however, were more stable. When extended to 40 feet, winds of 70-76 and 75-81, respectively, were required to cause a tip-over. Ultimately, the 53 mph gust that occurred at the practice fields was sufficient to tip the Marklift when extended to 40 feet, but not the SkyJack or JLG lifts.

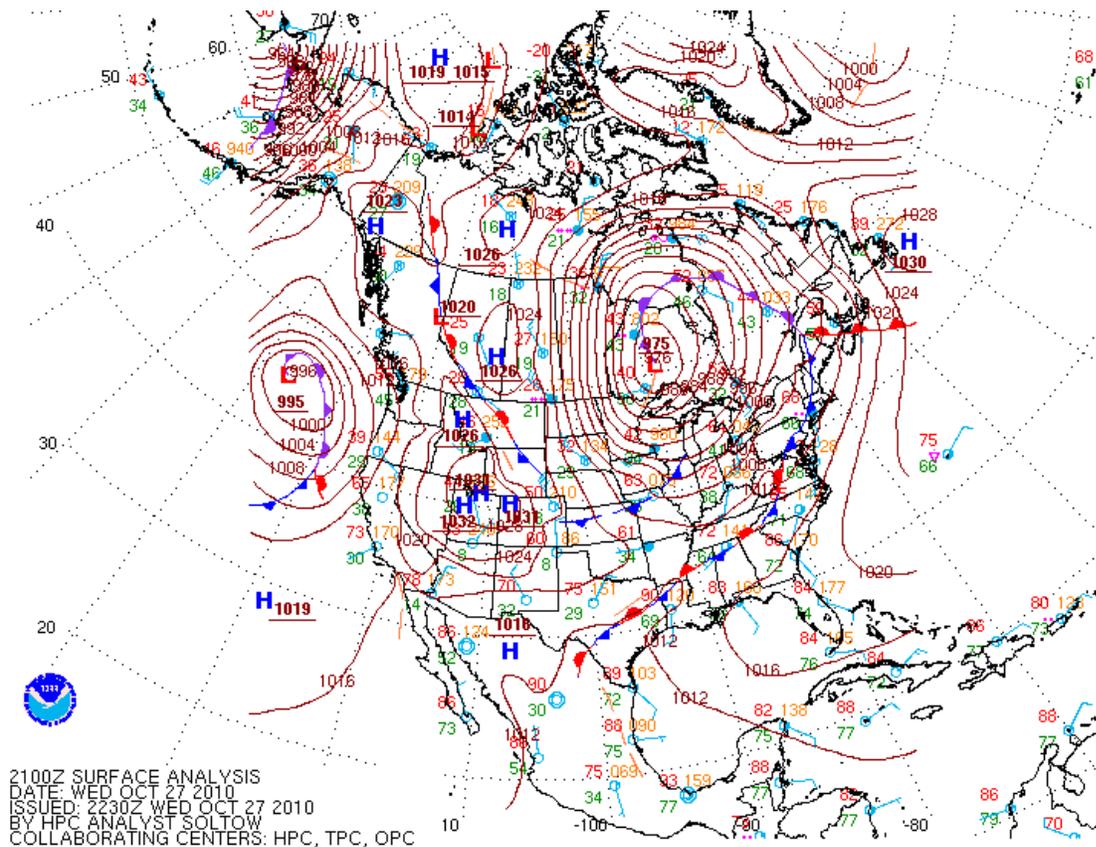
On October 27, an unusual weather system affected South Bend. According to Rappolt, at the time of the accident, an intense low pressure system, depicted below, centered over south central Ontario, Canada.

As the low pressure system passed to the north of South Bend, wind speeds from the southwest increased in velocity, although no thunderstorms occurred. Because the weather system was moving from west to east, wind speeds on campus lagged behind those at the airport. Thus, according to experts, while the strongest gust at the airport occurred at 4:29 p.m., the strongest gust on campus did not occur until approximately 4:55 p.m. when the lift fell over.

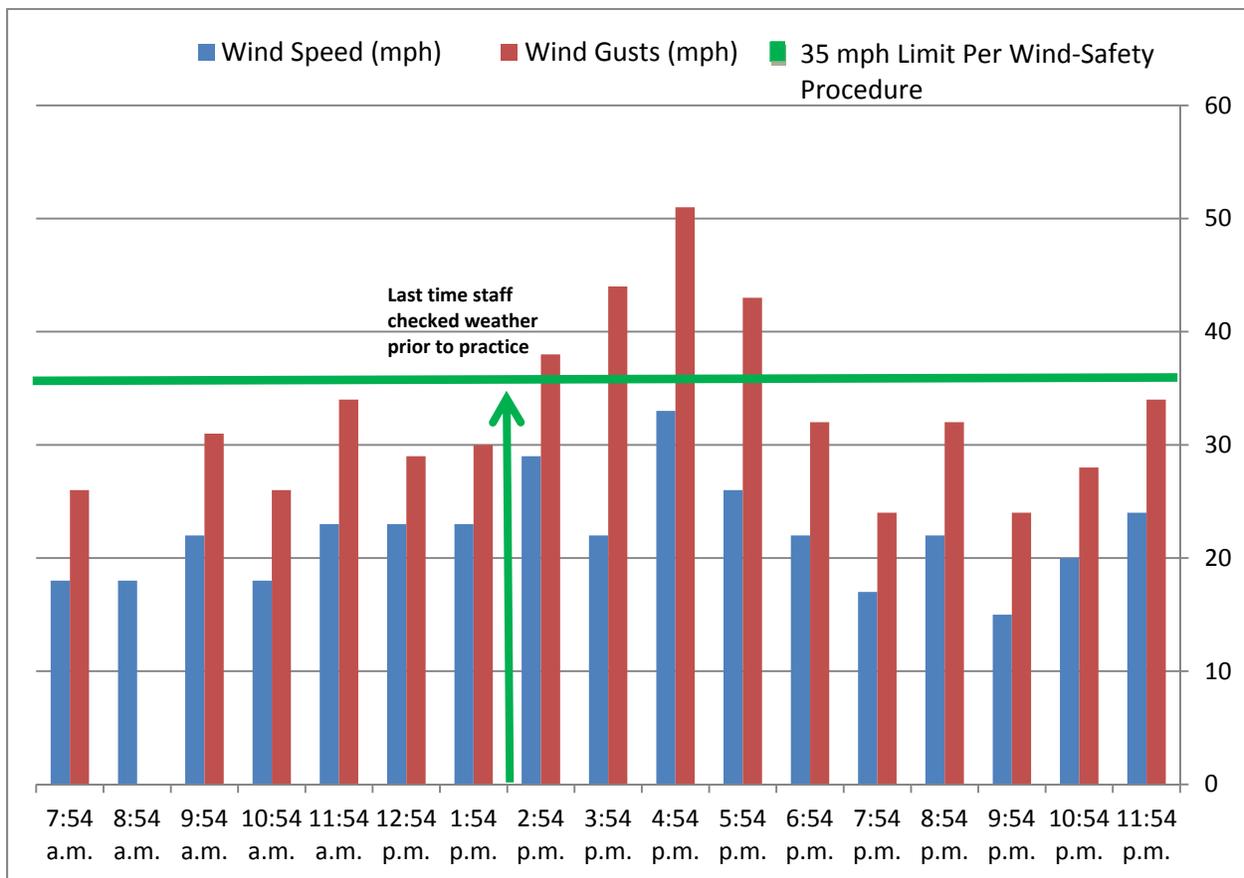
**WIND SPEEDS REPORTED AT SOUTH BEND REGIONAL AIRPORT BY NATIONAL OCEANIC AND ATMOSPHERIC ADMINISTRATION: WEDNESDAY, OCTOBER 27, 2010<sup>4</sup>**

As illustrated by the bar graph below, wind speeds increased significantly from the time the staff last checked the weather and went outside for football practice to the time of the accident.

When staff members checked the weather prior to practice, they saw reports of 23 mph sustained winds with 30 mph gusts. But wind speeds increased during practice, punctuated by

<sup>4</sup> Due to the lag in reporting time, the charts depicting NWS wind data do not illustrate real-time gusts. For example, the 51 mph gust at 4:54 p.m. in this chart does not reflect the gust that caused the accident. Rather, the 51 mph gust depicted above occurred between 4:44 and 4:54 p.m. at the South Bend Regional Airport. Experts determined that the gust that caused the accident, which was 53 mph, occurred at the airport at 4:29 p.m. and, on the field, at approximately 4:55 p.m.

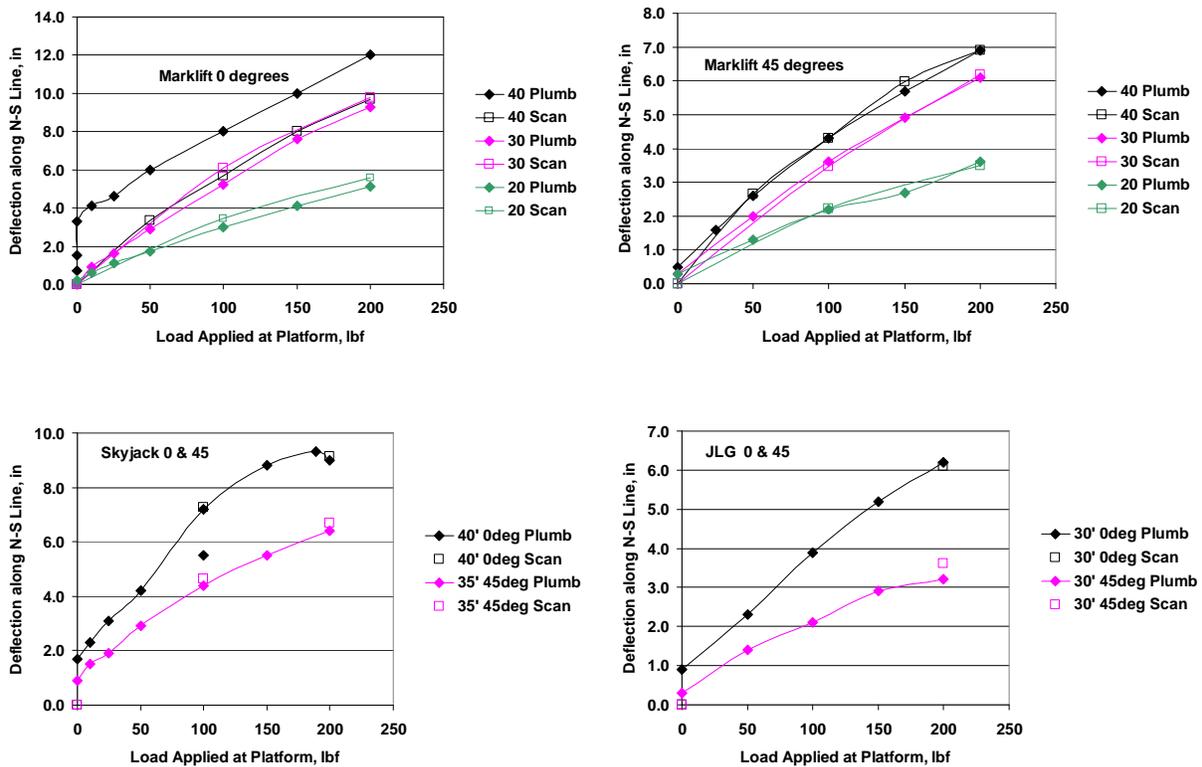
Each lift was tested by applying a series of horizontal forces to the lift’s platform at zero degrees (perpendicular to the long axis of the lift), and at 45 degrees to simulate southwest winds. Results of the deflection tests were measured both with a manual plumb bob hung from the platform and with a laser scanning instrument. The laser scans were then assembled into 3-dimensional computer-based drawings that Peterka could use to measure platform displacement and rotation. When raised to similar heights and placed under similar forces, the Marklift experienced more deflection than the SkyJack and JLG lifts, as depicted by the graphs below.

Peterka then used the deflection data, combined with the wind load analysis he had previously performed, to calculate the lifts' different tipping points. He separated the wind gust speed into North-South and East-West components for application to the scissor lift structures and applied the wind to various elements of the lift, including the platform, lifting section members, and base section, to obtain forces on those individual objects. He then calculated the wind force for each section, and balanced the wind-applied forces against the weight of the lifts. Ultimately, Peterka concluded that the lifts had significantly different tipping points, as illustrated below.

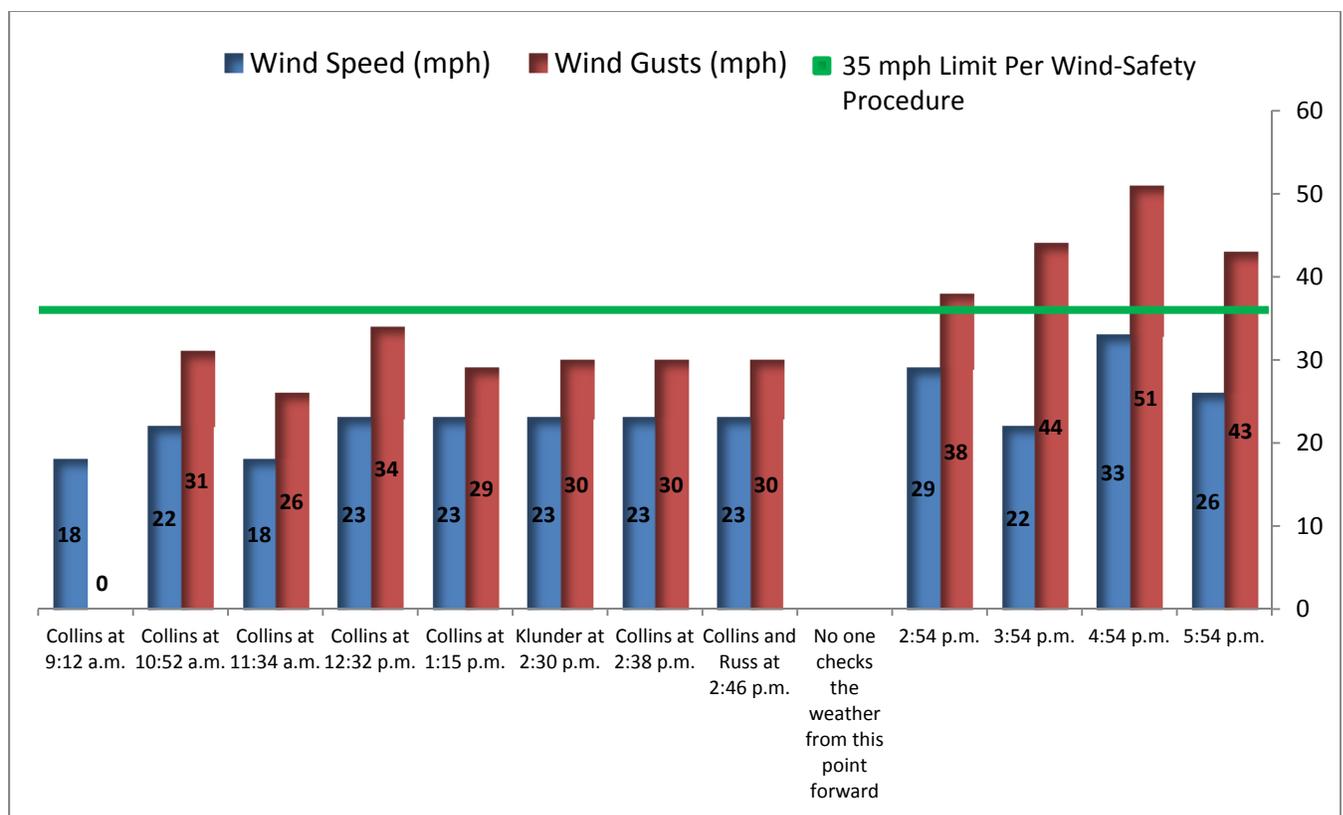
### ONLINE WIND DATA GENERALLY AVAILABLE ON OCTOBER 27, 2010<sup>6</sup>

The lack of real-time weather information on the practice field played a role in the accident. After practice started, wind speeds increased at a steady pace, with reported gusts reaching 38 mph and 44 mph before the accident. Had Collins or Russ accessed real-time

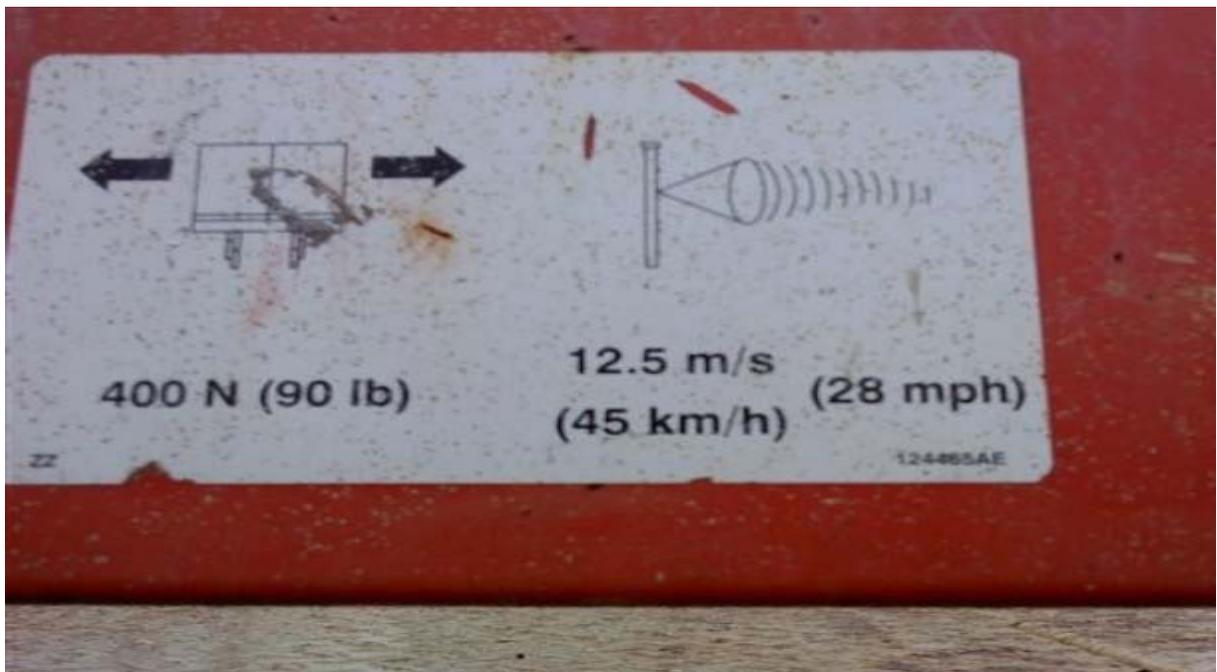
The SkyJack does include a label that references 28 mph, and that label (with some variations), along with all other labels, is depicted in the manual.

According to expert David Merrifield, the label “is not a warning according to ANSI” because it fails to meet ANSI’s safety label criteria. Indeed, according to Merrifield, “[i]t is not clear that a user would have recognized the symbol on the label as an indication of wind speed.” Moreover, after examining the SkyJack’s manual, Merrifield concluded that “it is not immediately apparent that 28 mph is the proper maximum wind speed for that machine.” However, even if the staff concluded that a 28 mph wind limit should be applied to the SkyJack, Merrifield stated that the staff had no reason to apply that limit to different machines like the Marklift. Ultimately, Merrifield “would not expect the SkyJack machine, manual and placards, taken in their entirety,” to have changed “the behavior of Notre Dame vis-à-vis the Marklift.”

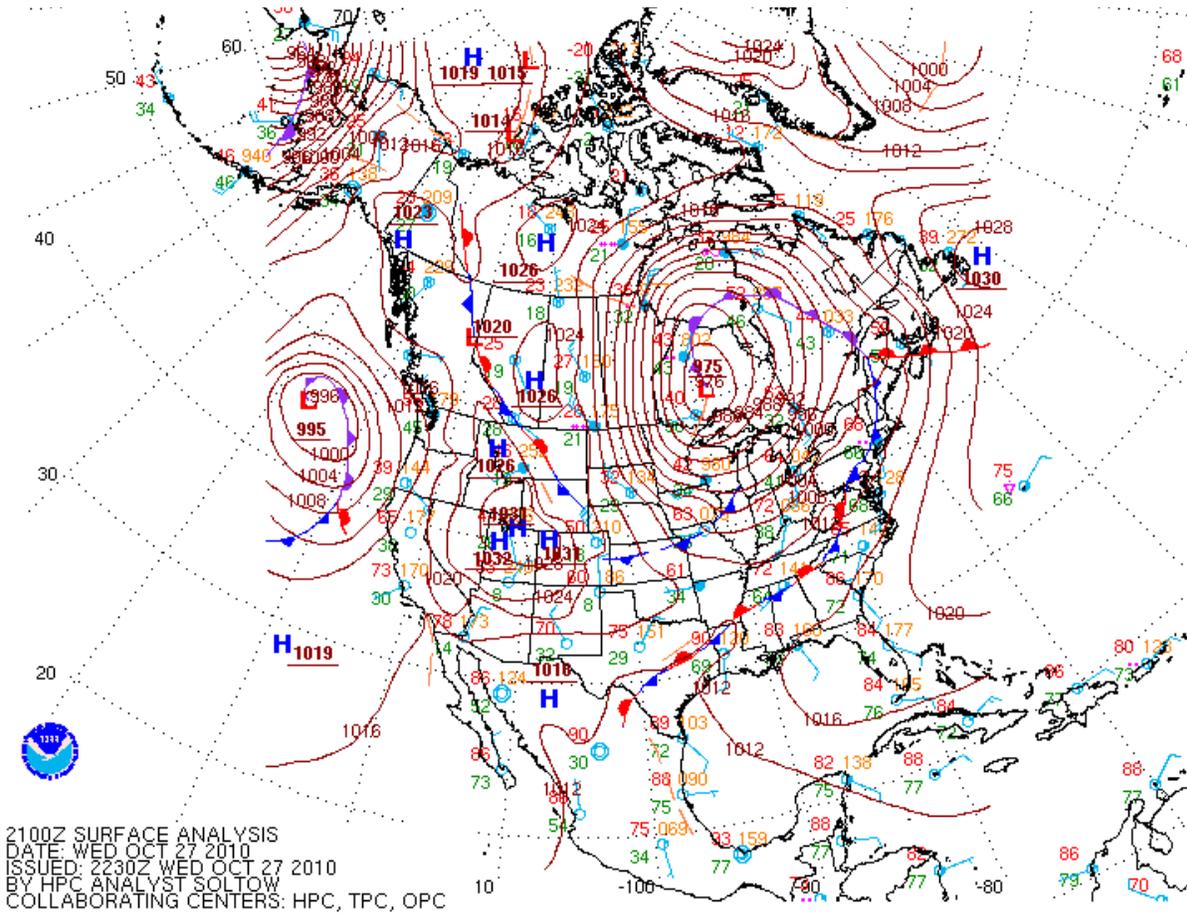
At the time of the accident, about 4:55 pm EDT on 27 October 2010, an intense low pressure system was located in Canada north-northwest of South Bend, IN (see Figure 2). At the center of the low pressure system, a barometric pressure of 975 mb was recorded generating strong winds in the surrounding surface environment (circulating counterclockwise relative to the storm center). While the system was sufficiently distant that South Bend did not experience the low pressure (29.61 inches of Mercury = 1002.7 mb; 1013 mb is the average atmospheric pressure under standard conditions), strong wind speeds did extend from the low pressure area. Wind speeds from the southwest increased in magnitude at the accident site as the low pressure system passed by to the north.

Figure 2. Weather surface analysis map for the time of the accident showing an intense low pressure in Canada north-northwest of South Bend.

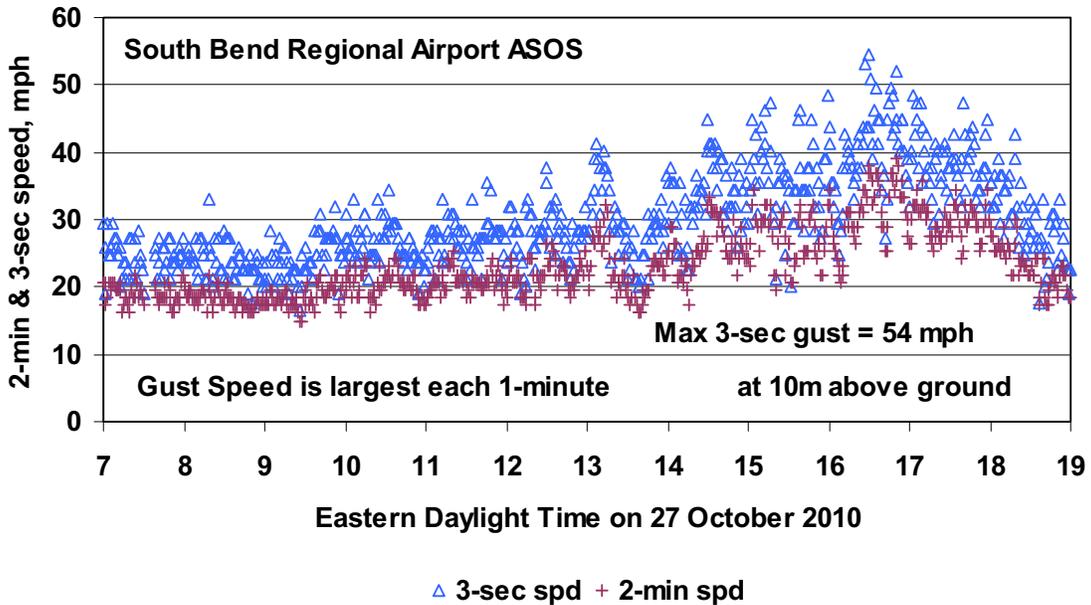
Figure 3 shows wind speeds and directions at the airport for the hours leading up to the accident time of 4:55 pm EDT. In the figure, measured 5-second gusts have been converted to 3-second gusts to be compatible with wind load provisions of ASCE 7, the national wind load standard, since elements of that standard are used in this report to calculate wind loads (for example the largest 5-second speed of 53 mph becomes a 3-second speed of 54 mph). In addition, 30-minute running averages (average over 15 minutes before to 15 minutes after each point in time) of both wind speed and direction have been computed and are presented in Figure 3.

Figure 3a. Two-minute mean wind speeds and 3-second gust speeds from South Bend Regional Airport.

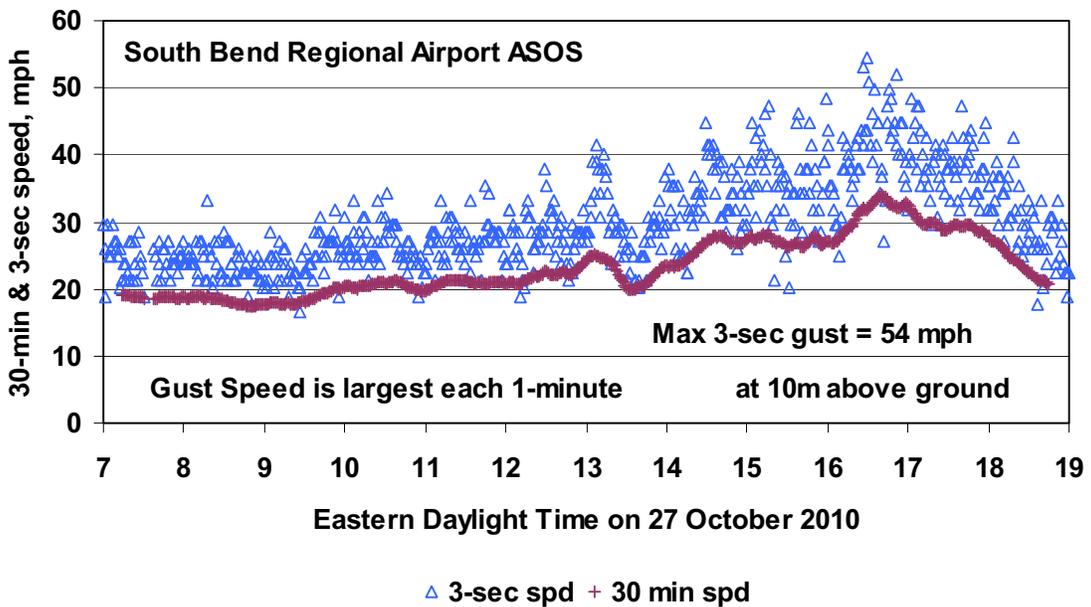
Figure 3b. Thirty-minute mean wind speeds and 3-second gust speeds from South Bend Regional Airport.

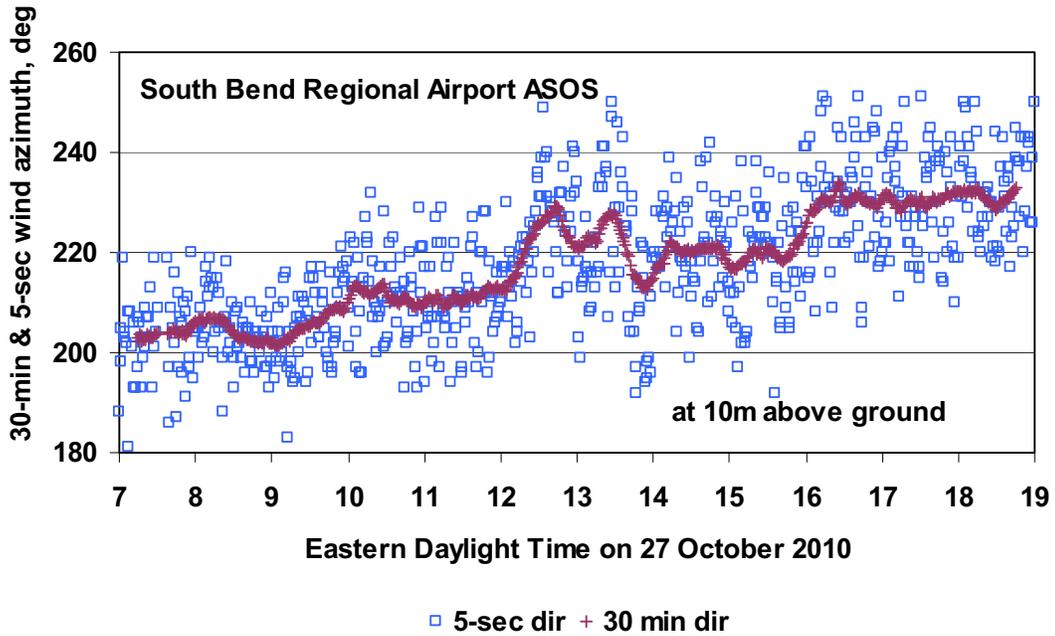
Figure 3c. Thirty-minute mean wind azimuth and 5-second azimuths from South Bend Regional Airport.

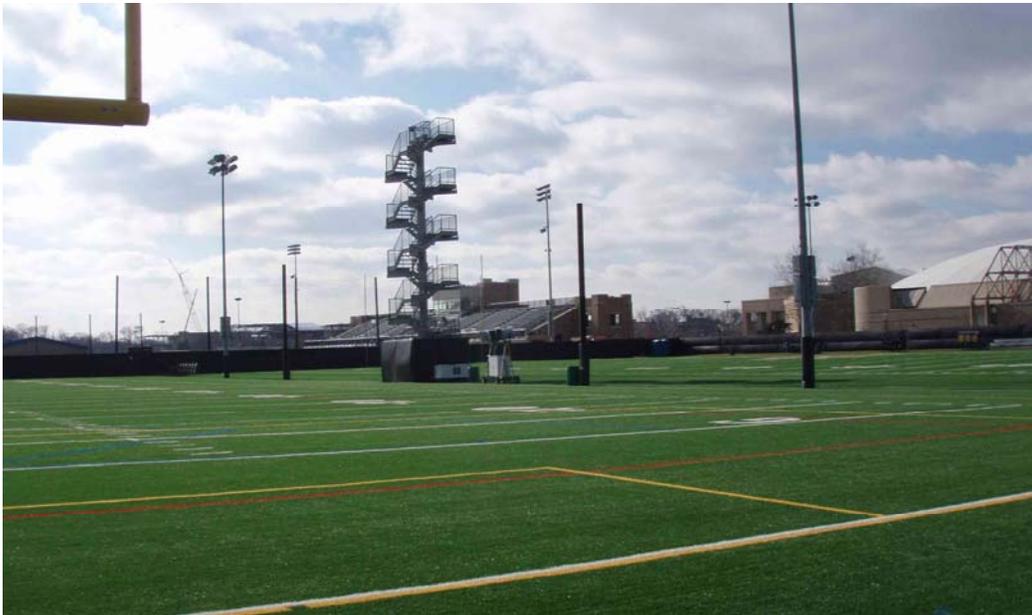
Figure 4. Photograph looking upwind from the accident site (Southwest) to the direction from which the wind gust occurred that tipped over the Marklift.

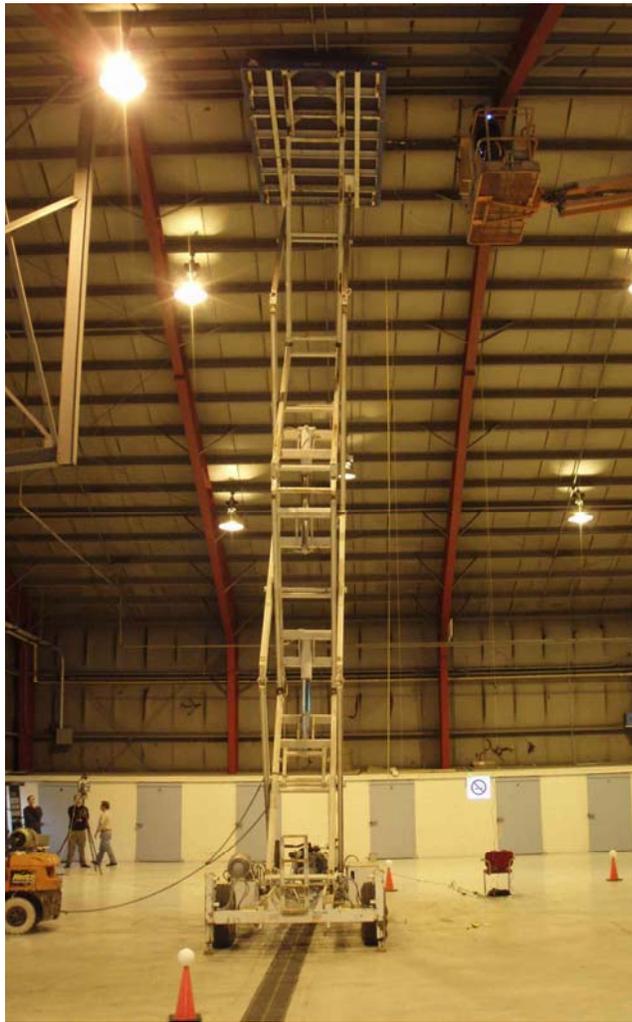
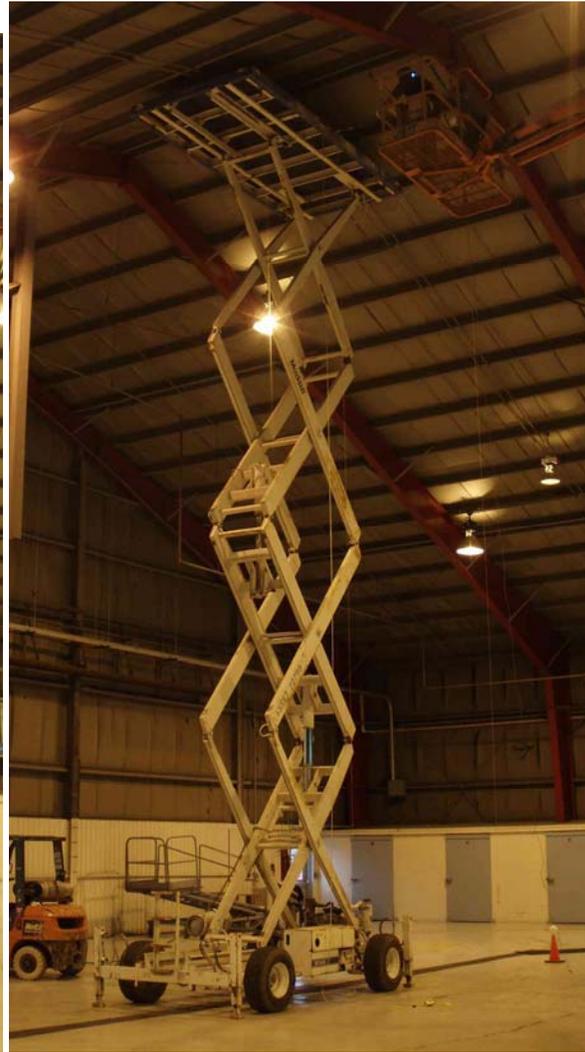
Figure 5. f) and g) Marklift under 200 lbf load at zero degrees.

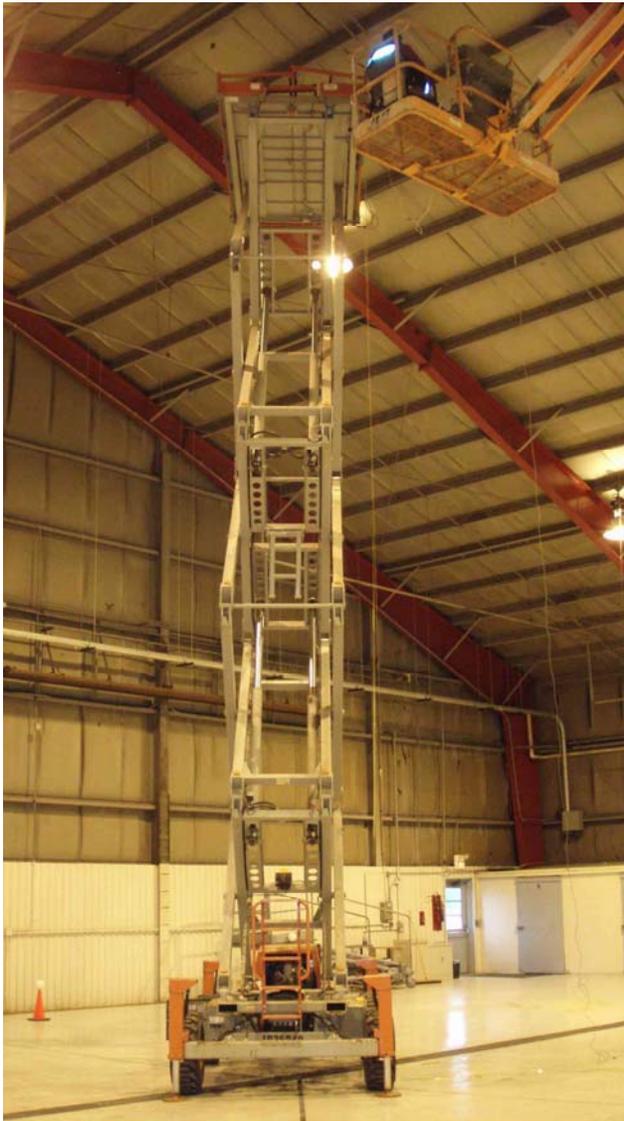
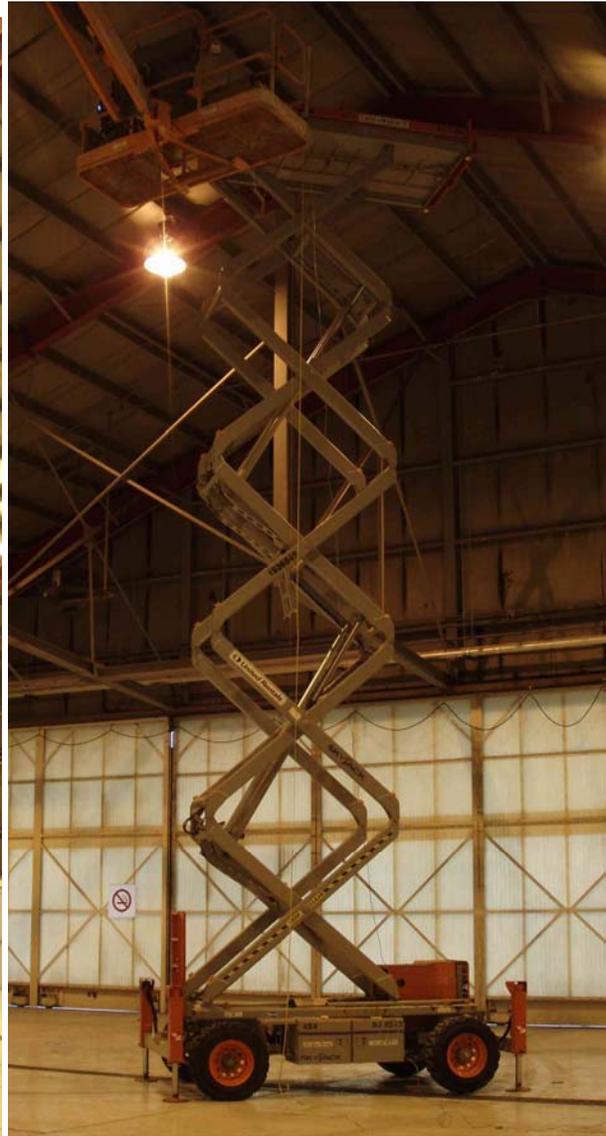
Figure 5. h) and i) Skyjack under 200 lbf load at 45 degrees.

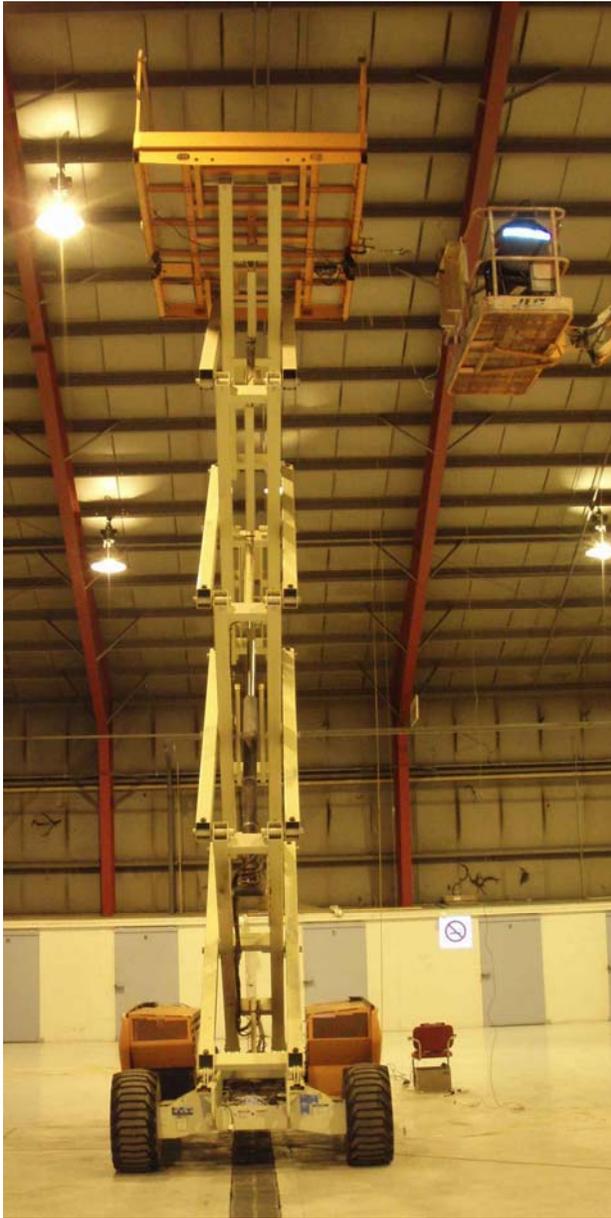
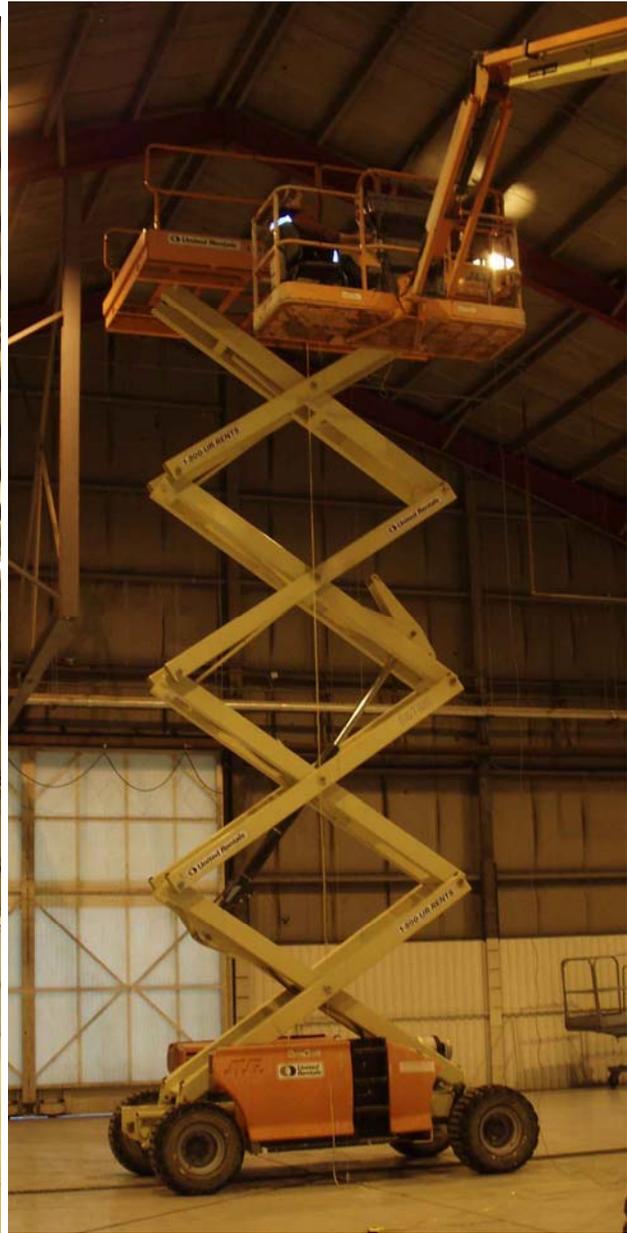
Figure 5. j) and k) JLG under 200 lbf load at zero degrees.

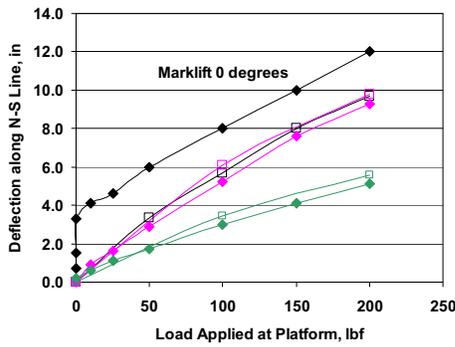
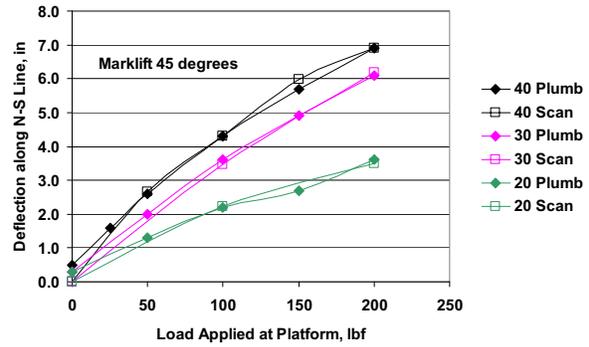
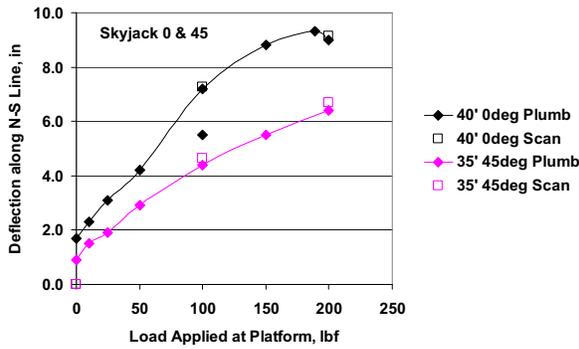
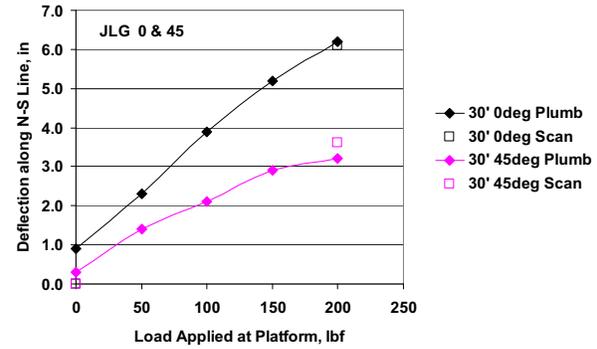
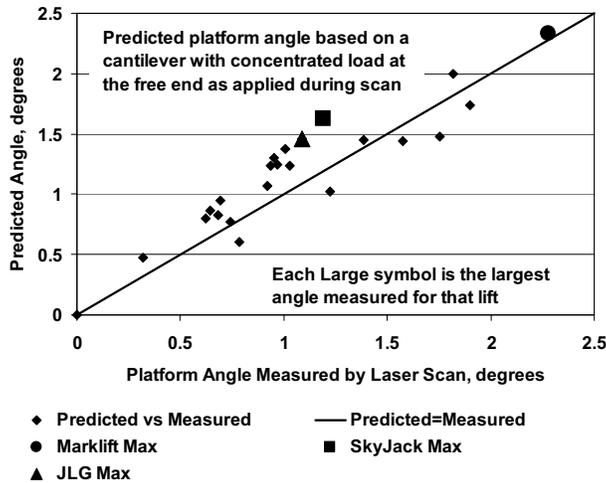
Results of the deflection tests are shown in Figure 6. Each part of the figure shows the applied force in pounds (lbf) on the horizontal axis and deflection in inches in the north-south direction on the vertical axis. Plumb bob measurements are shown as solid diamonds while scan data are shown as open squares. Parts a) and b) are for the Marklift at 0 and 45 degrees, part c) is for the Skyjack, and part d) is for the JLG. Plumb bob and scan results match very well except for the Marklift at a height of 40 ft in part a) at 0 degrees. For this case, the Marklift had a deflection of several inches with almost no applied load. It is likely that the no-load scan deflection was about 3 inches different from the no-load plumb bob measurement. Since the 0 degree case is not of interest for the accident analysis, and because we are mostly interested in the slope of the deflection curve, this result is of no consequence for our analysis. The good match between plumb bob and scan data for the remaining data provides a solid basis for the analysis of the next section.

Figure 6. a) to d) Results from the deflection tests;  
e) platform angle results compared to a cantilever model.

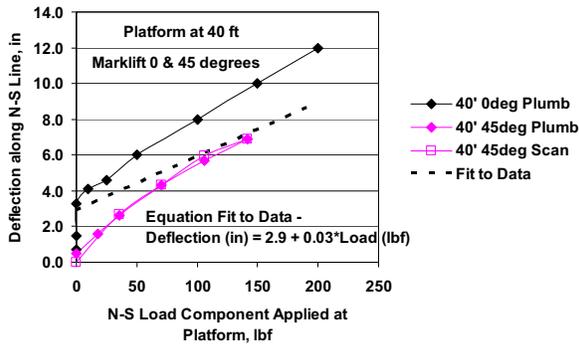
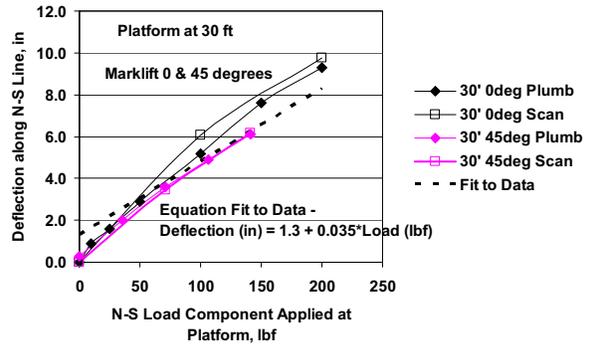
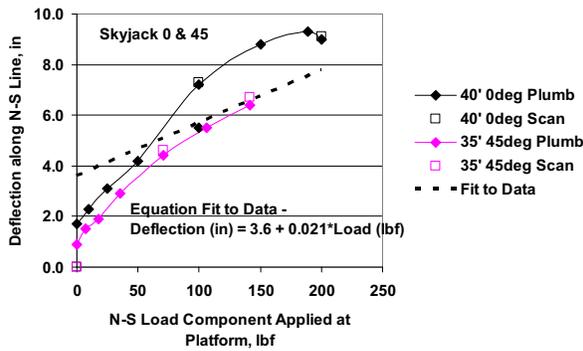
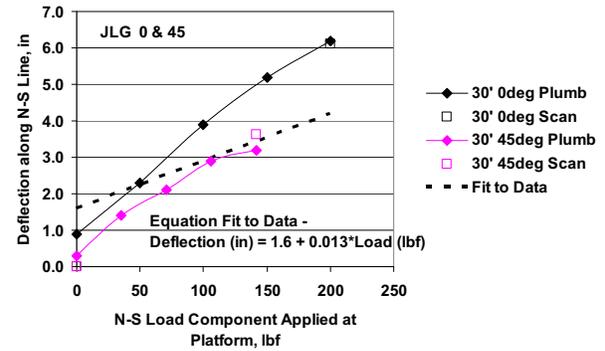
Figure 7. Deflection models for the three lifts.

Lift deflections in the N-S direction as a function of load in the same direction as shown in Figure 7 are summarized below. The important part of the fitted curve is the extension to higher loads.

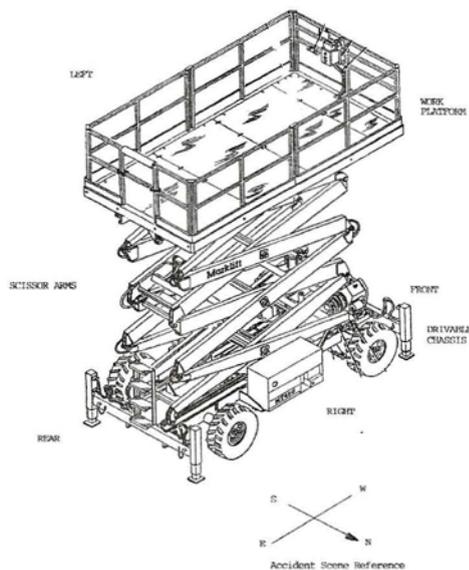
Fig 1 – Overall Lift Drawing

The Lift is characterized in the Aerial Platform Industry as a “Rough Terrain Scissor Lift”. The Lift (Figure 1) consists of a large work platform supported by four (4) pairs of scissor arms which are attached to a drivable chassis. The Lift may be driven in the elevated condition up to an extended height of thirty (30) feet. Above the thirty (30) foot elevation The Lift is designed so that it is supported by four (4) hydraulic outriggers which are manually extended and pinned in the horizontal direction and hydraulically extended in the vertical direction from controls at the platform operating station. The purpose of the four (4) outriggers is to increase the stability of The Lift when it is operated above thirty (30) feet.

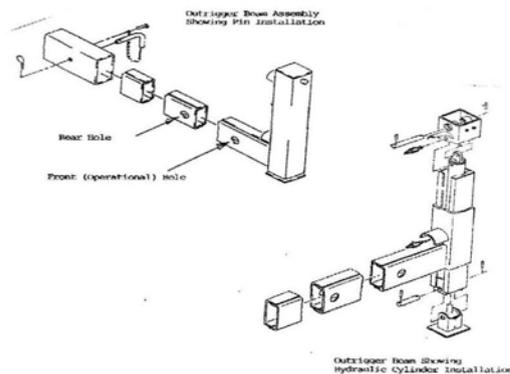
Fig 2 – Outrigger Drawing

Second, four pins normally attached to the outrigger beams were missing and the outrigger sockets were corroded such that the beams were “frozen” 1-5 inches beyond the normal position.

Further inspection of The Lift revealed two areas of damage that pre-existed the accident. They were, damage to the platform railing assembly and corroded and unpinned outrigger assemblies. Additionally, I determined that the center pivot shaft of the top inner scissor arm assembly was fractured and that a portion of the shaft was found lying on the ground near The Lift after the accident.

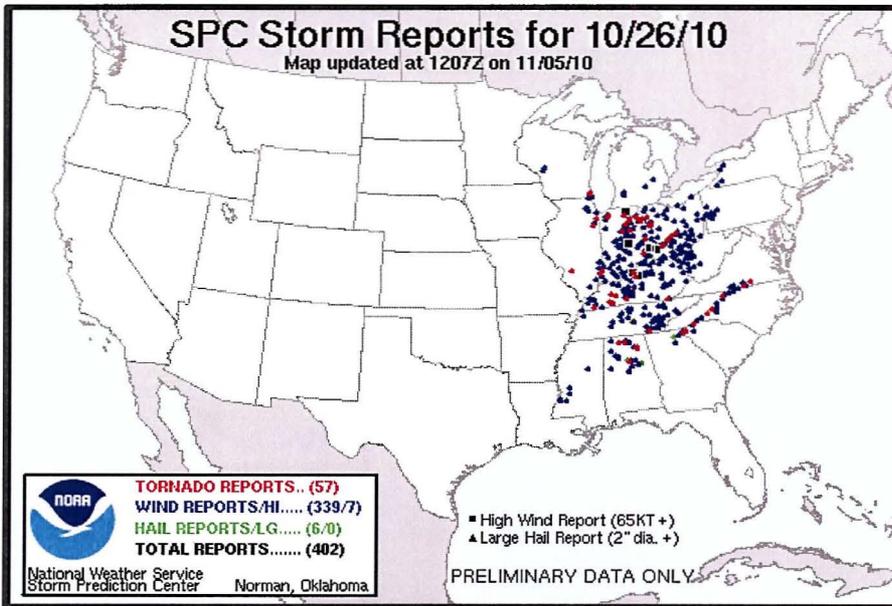
*The squall line produced widespread wind damage across the Midwest with wind gusts of 50 to 60 mph with some locations recording gusts up to 75 mph! In addition to the strong winds, some of the storms produced tornadoes in Wisconsin, Illinois, Indiana, and Ohio. The image below (Figure 4) shows the storm reports as relayed to the Storm Prediction Center from the day.*

Figure 4: NWS Northern Indiana has confirmed 13 tornadoes in their county warning area (CWA) in northern Indiana and northwestern Ohio.

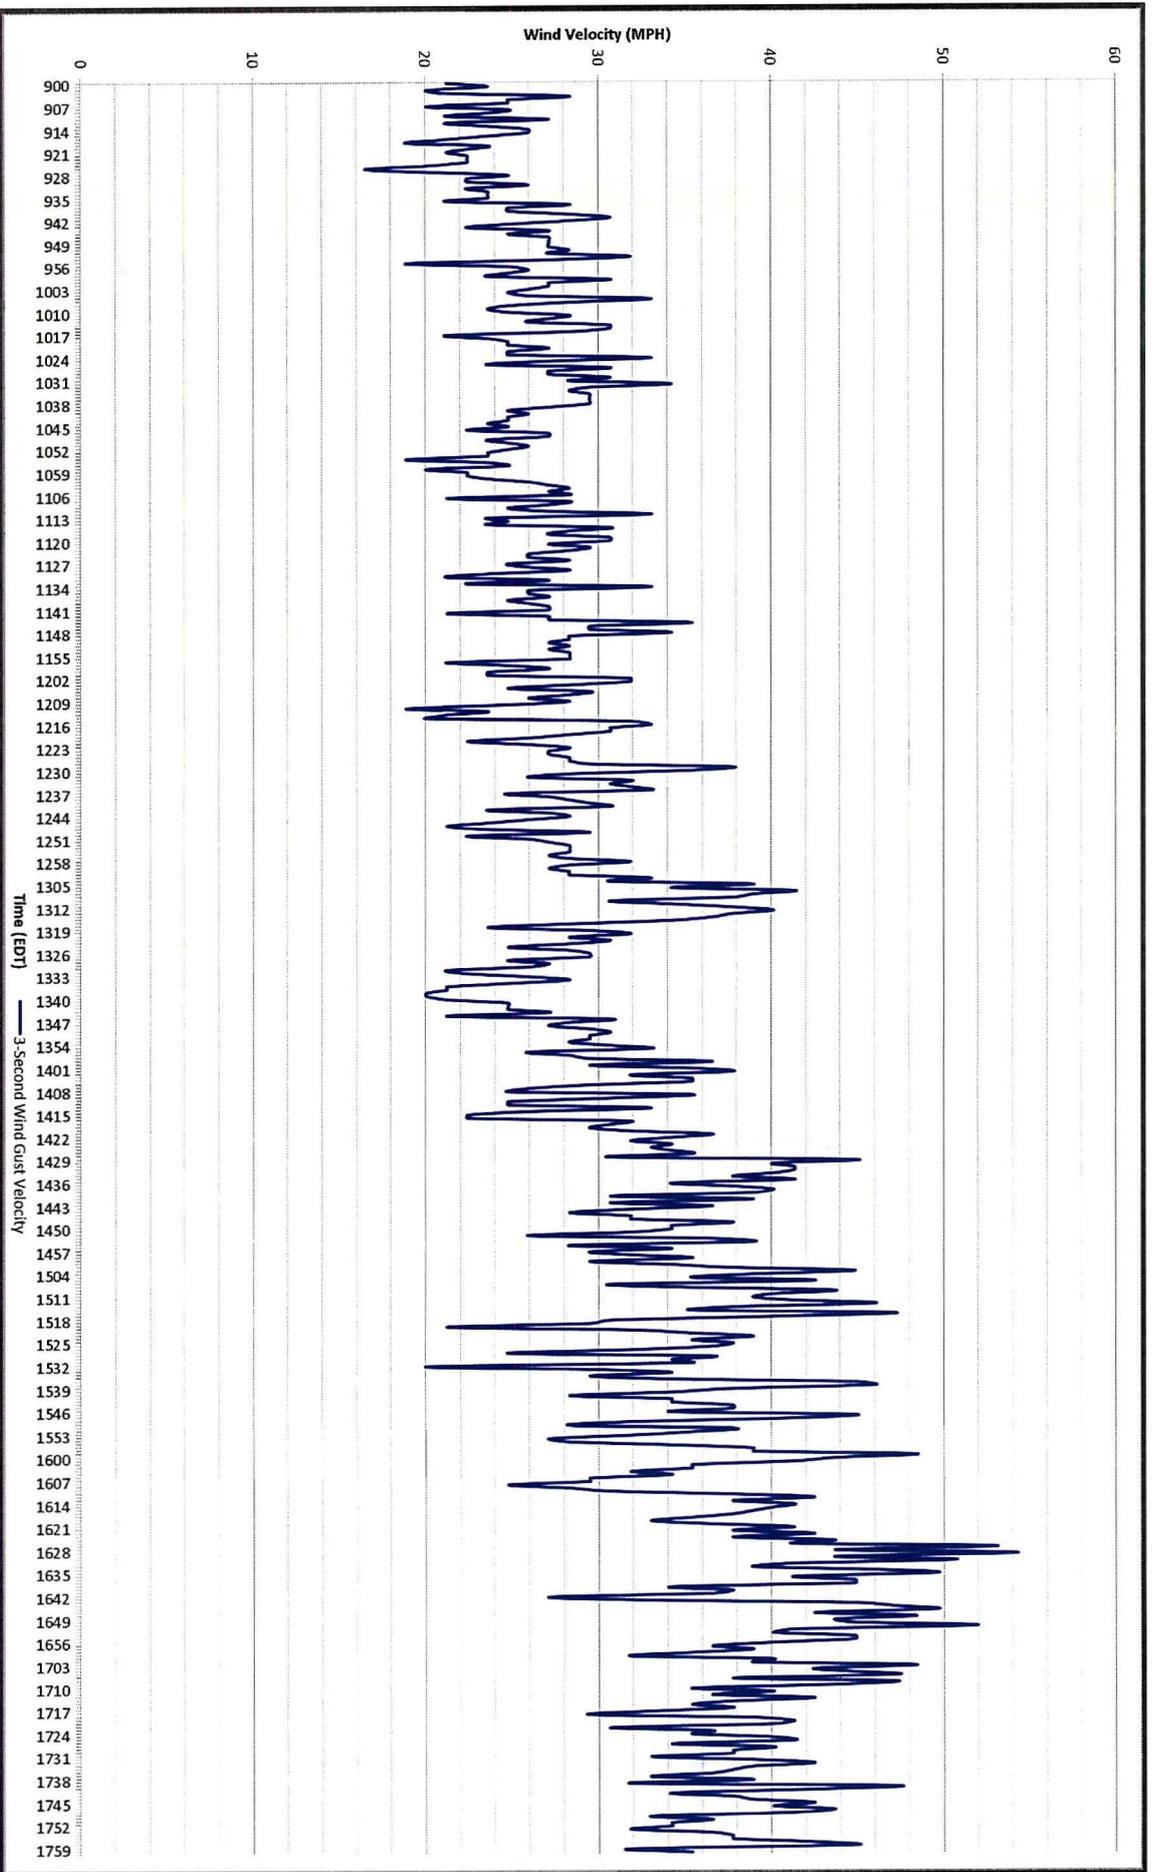
Figure 5 is a graph depicting the 3-second wind gust velocity observed by the KSBN ASOS from 900 AM EDT through 600 PM EDT on October 27<sup>th</sup>, 2010.

Figure 5: 3-second wind gust velocity observed by the KSBN ASOS from 900 AM EDT through 600 PM EDT October 27<sup>th</sup>, 2010. Time step 1-minute.

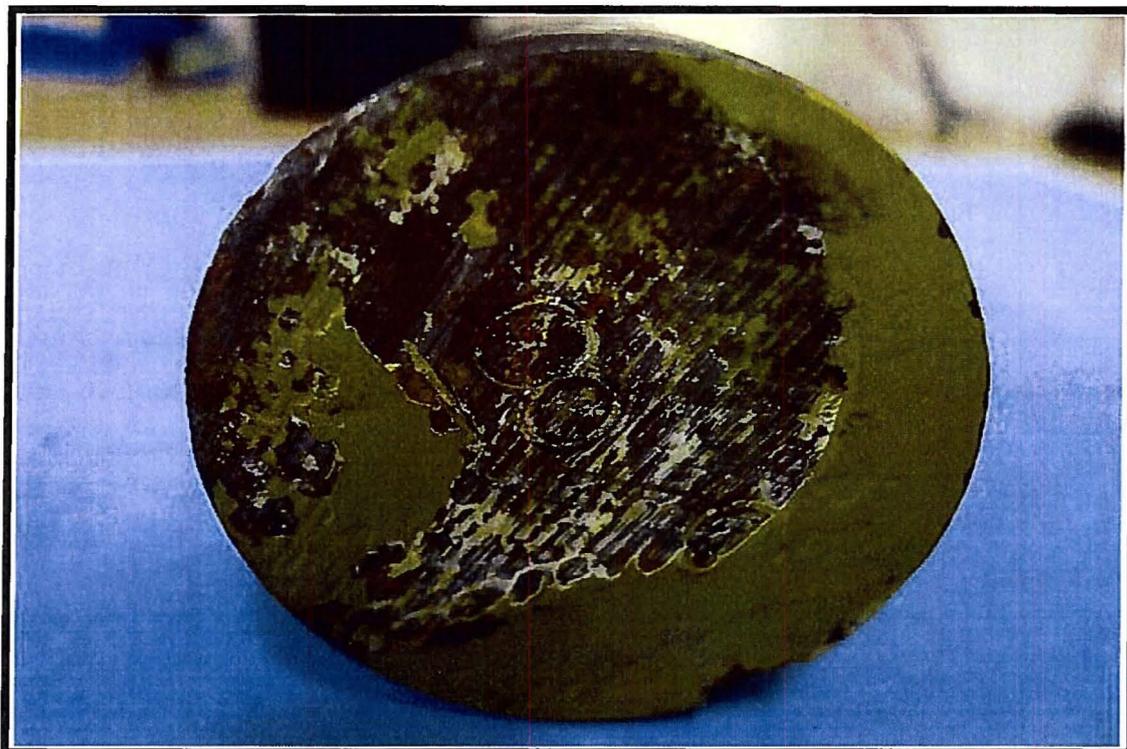
The steel pin provided to SEA is approximately 2" in diameter and 5 1/2" long (**Figure 1**). One end appears to be saw cut and is stamped with the number 8 (**Figure 2**). There is a depression drilled near this end and scrape marks or gouges lead from the depression to the end of the pin (left side of Figure 1). This depression appears to have been a receptacle for a retention screw, and the scrape marks are consistent with the pin being forced from the joint despite the presence of the retention screw.

**FIGURE 2:** Cut end of steel pin.
